APPLIED GEOLOGY: MINERALOGY AND PETROGRAPHY OF THE BUILDING MATERIALS OF ARAČ RUINED CHURCH (VOJVODINA, SERBIA)

Karolina BIACSI¹ & János KALMÁR²

Abstract. The Arač (Aracs) ruined church is located Vojvodina on the left side of the River Tisa. It is an unique standing medieval church monument of Serbia. As a part of the restoring and conservation works, among 2009–2011 the samples of stone and man-made materials of this building were taken and analyzed. Using geological methods, the origin, the technology and the weathering processes of these materials were emphasized. Thus, the most probable origin of the stone material was Buda Mts., close to Budapest; the clayey-silty material for the bricks came from the surrounding old Tisa floodplain sediments, the lime for the binding and rough-casting material was obtained from carving by-products of the stone material and the sand of mortar and plaster was transported from the alluvia of the River Mureş. The microscopic study proved, that two or more plastering and painting phases were executed. The weathering of the building elements began after the outbreak of fire what destroyed the wood roof of the church. On the stone elements, after

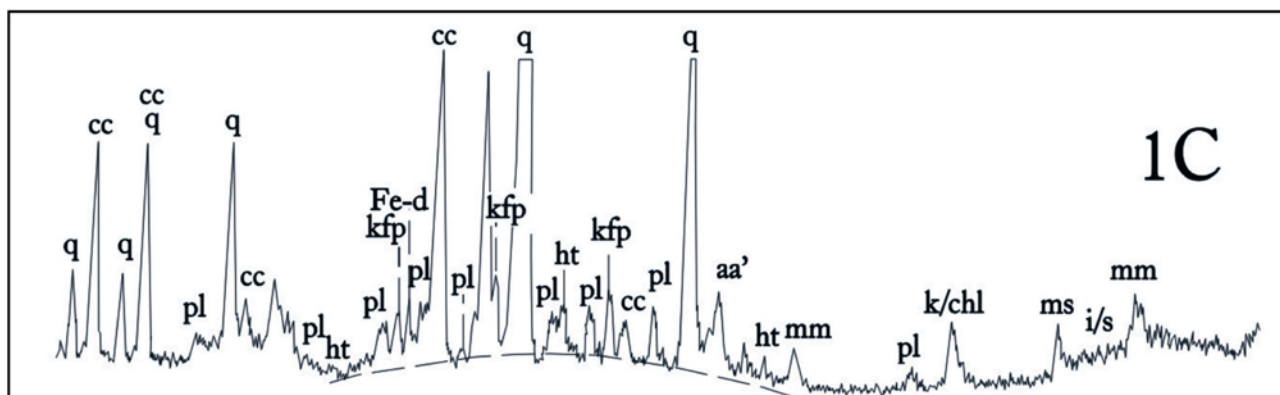
these minerals were confirmed. In three samples, peaks of edenite [$\text{NaCa}_2\text{Mg}_3\text{AlSi}_7\text{O}_{22}(\text{OH})_2$] (Table 2) were identified. Among of carbonates, beside of calcite the dolomite appears (Fig. 2).

Figure 2. X-ray diffractogram of C1 mortar sample. aa', total clay minerals; cc, calcite; Fe-d, iron bearing dolomite; ht, hematite; 1/s, illite-smectite mixed layer; k/chl, kaolinite and/or chlorite; kfp, K-feldspars; mm, montmorillonite; ms, muscovite; pl, plagioclase; q, quartz.

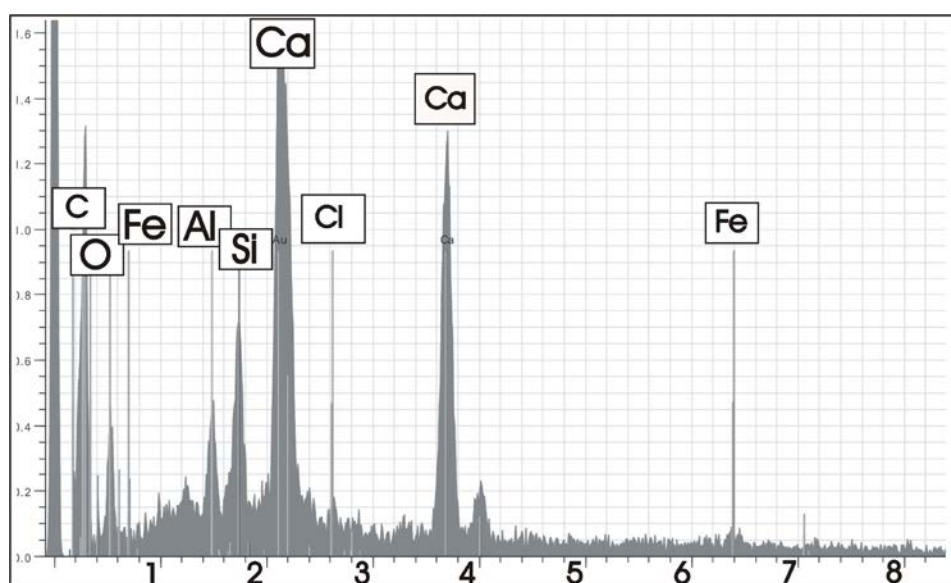
colored painting film, 2.1–4.1% iron was found (Fig. 3). It is known, that in medieval paintings, the main coloring substances were the natural (red, orange, yellow, brown) iron oxides and hydroxides.

Figure 3. Electron microprobe spectrum of medieval painting film, from the pointed arch of the sanctuary

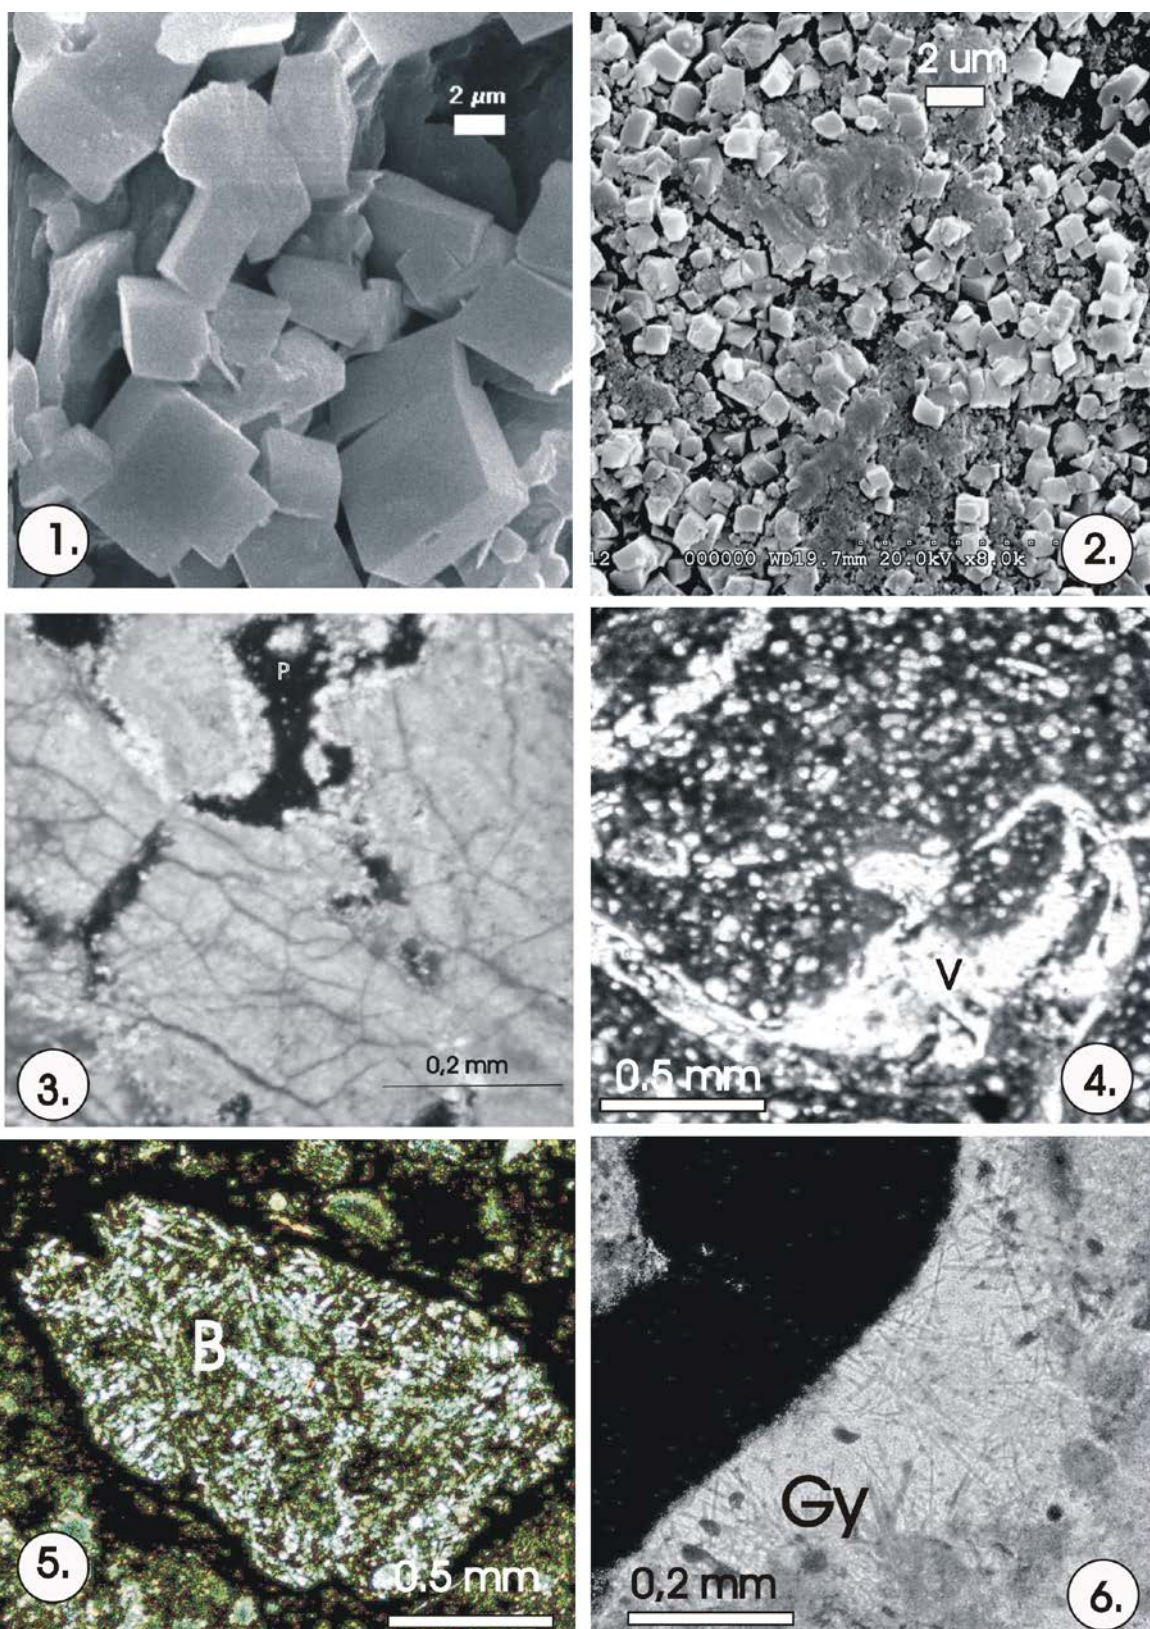
Plate 1

In the SEM photo of T2 plaster sample, the groundmass appears as Ø2–3 µm carbonate rhombohedrons with lamellar clay mineral flakes and rare gypsum prisms (Plate 1, photo 2).

The “geological” transformations of these rocks can be recognized, when the carved surface cuts them, i.e. the weathered, karstic surface, the well crystallized calcite (Plate 1, photo 1), limonite or clay-filled veins, voids or pores. On the contrary, if these ones are related to manmade surfaces that is sure, that the alteration was produced after the carving of the stone object and shows a secondary character.

The pollution of stones and other materials mainly by sulfates and smut has no doubt anthropogenic origin. If the acid rain, resulted from activity of farther industrial centers (e.g. Novi Sad, Timișoara, Szeged) reacts with carbonate, that result gypsum (Plate 1, photo 6), anhydrite, glauberite and other salts.

- Photo 1. Euhedral calcite crystals from natural vein filling of Late Eocene limestone. SEM image
 Photo 2. Euhedral and hemihedral calcite crystals and platy clay minerals in limy painting. SEM image
 Photo 3. The fire fissure network cuts “geological” calcite liners of the pores of limestone. Thin section, + nichols
 Photo 4. Pores in brick mass, burned vegetal fragments, probably wheat or hemp husks (V). Thin section, || nichols
 Photo 5. Basalt grain (B) in the sandy fraction of the mortar. Thin section, + nichols
 Photo 6. Gypsum needle like crystals (Gy) in the pore of the brick sample. Thin section, || nichols

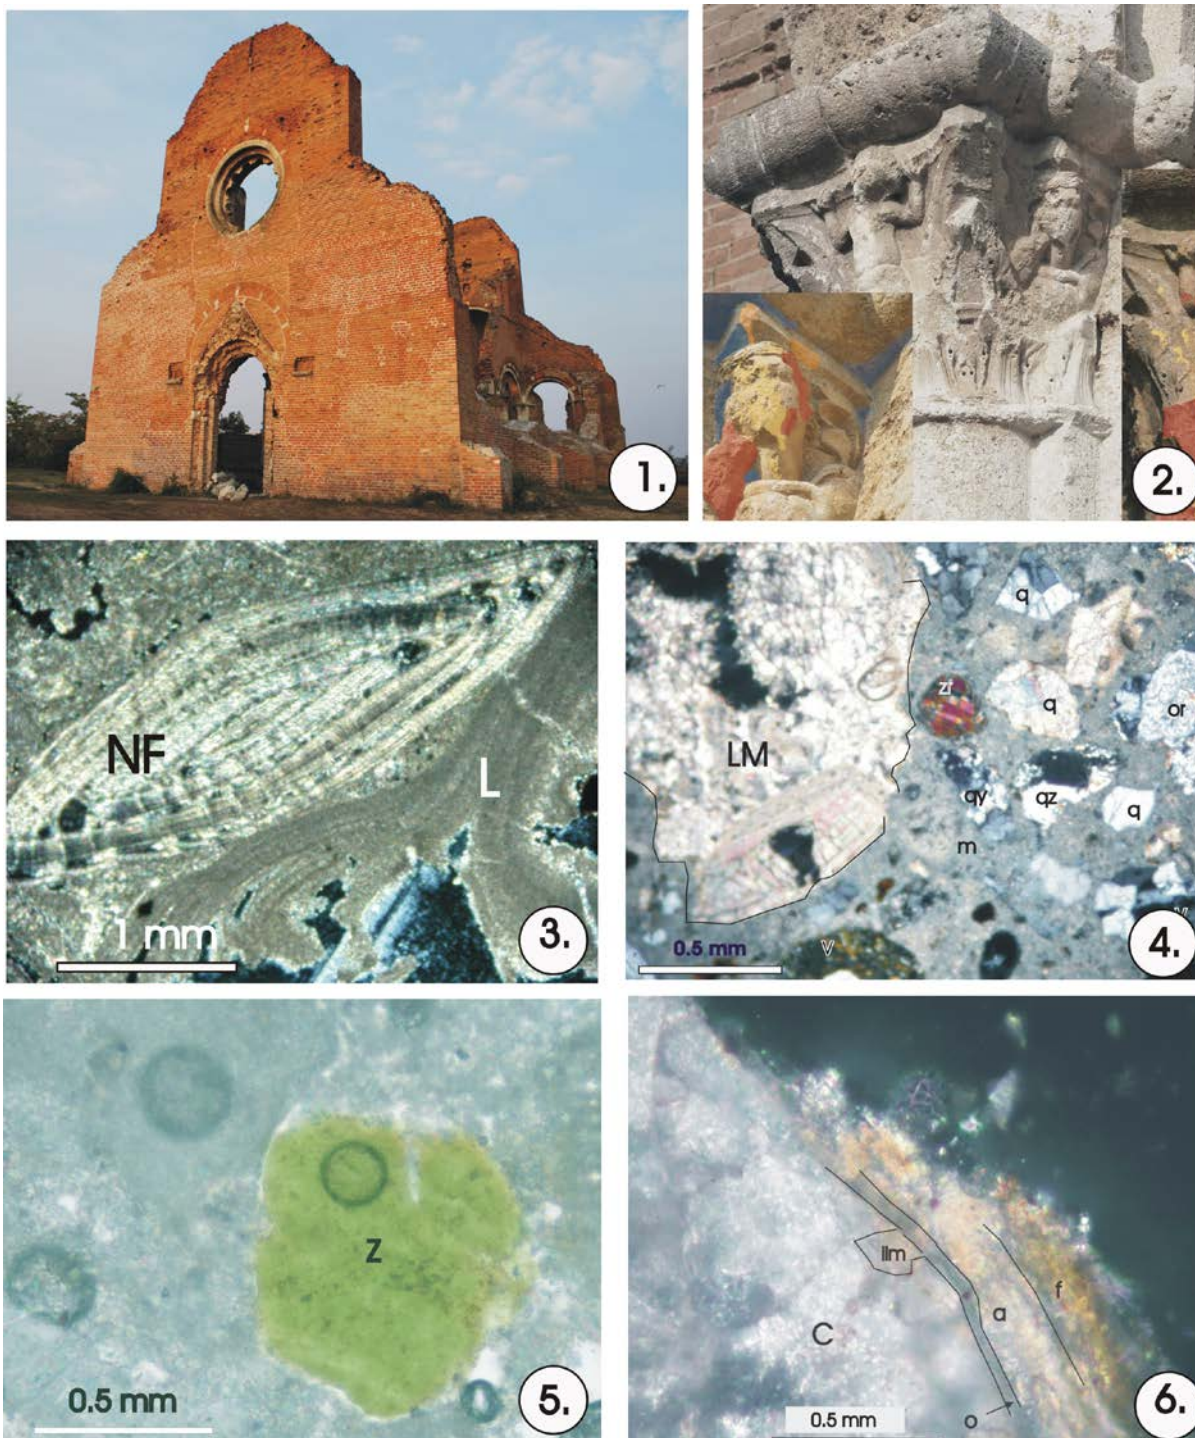
Plate II

On the surface of the limestones, from a few mm to a few cm in depth, a part of the fine grained carbonate groundmass is dissolved. The loose, friable weathering crust leaves the stone piece, whipping the carved details as stria, pillar-heads, palmetto, acanthus, statuary pieces (Plate 2, photo 2.)

Photo 2. The pile head with damaged carved works, Late Eocene limestone
