THE RED LAKE LANDSLIDE (UCIGAȘU MOUNTAIN, ROMANIA)

Viorel ILINCA¹ & Ion GHEUCA¹

¹Geological Institute of Romania, Caransebeș Street, no.1, Bucharest, Romania,
ilincaviorel@yahoo.com; i_gheuca@yahoo.com

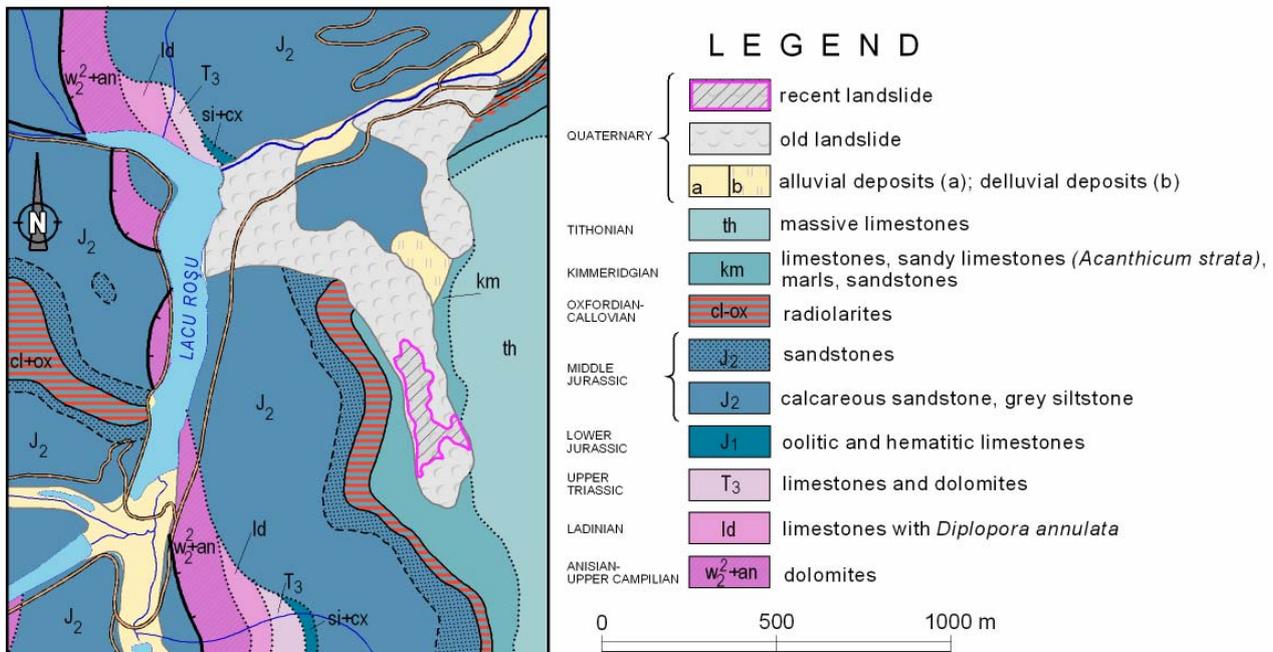
Figure 2. Geologic sketch of the Red Lake area (Săndulescu et al., 1975, modified).

From the geological point of view, the area is included in the Crystalline Mesozoic Zone (Median Dacides, according to Săndulescu, 1984), on the western part of the Marginal Syncline from the Bucovinic Nappe (Uhlig, 1903; Băncilă, 1958; Săndulescu, 1975). The rocks involved consist of a stratigraphic succession with age from Triassic to Upper Jurassic (Fig. 2).

The most rock here consist of sandstone, grey silt (Middle Jurassic), radiolarite (Oxfordian - Callovian) and limestone, sandy limestone, marl and sandstone (Kimmeridgian).

Generally, the maps show approximately the same stratigraphic succession, interpreted in different ways by different authors. While Săndulescu (1975) and Săndulescu et al. (1975) identified a nappe, others (Preda, 1967; Grasu, 1971) believed that the formations were in normal succession thus they excluded the possibility of a nappe.

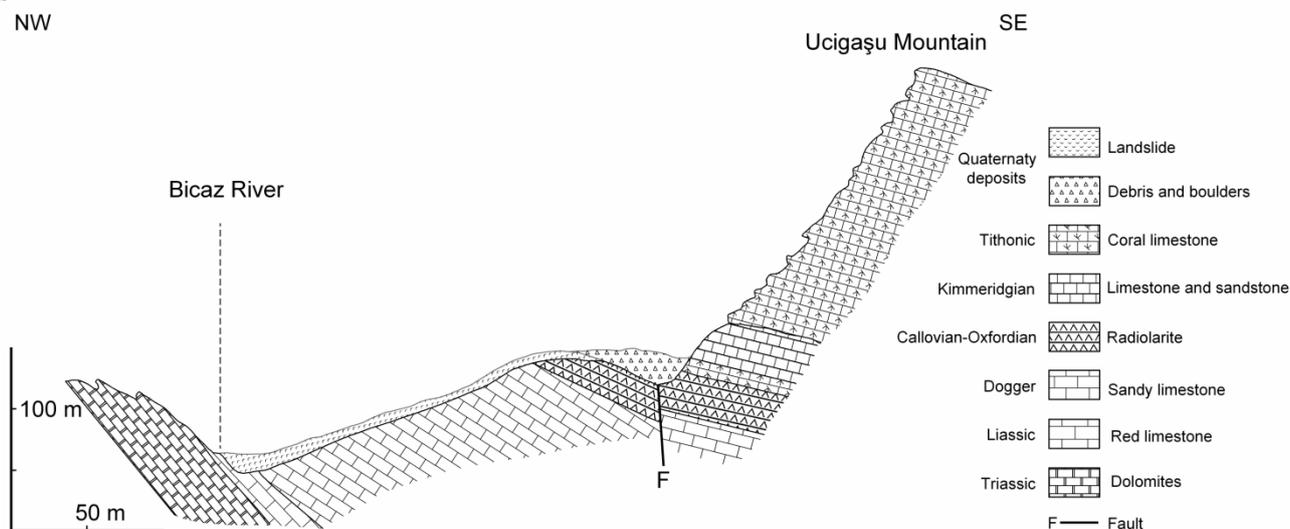
Figure 3. Cross-section between Ucigaşu Mountain and Red Lake (Preda, 1967).

The oldest formations contain dolomites and were dated to Anisian – Upper Campilian (Fig. 3). On this deposit, there are Middle Jurassic deposits, which consist of calcareous sandstone, grey silt and sandstone and occupy a much larger area near the Red Lake. Callovian - a thick, but obvious layer of radiolarite (jasper) which was identified in the field by all authors represents Oxfordian here. The Kimmeridgian is made up of limestone, marl and sandstone. The uppermost formation is represented by Tithonian, is located on the top of the Ucigaşu Mountain and consists of massive limestone, which dips 30-40° to the East.

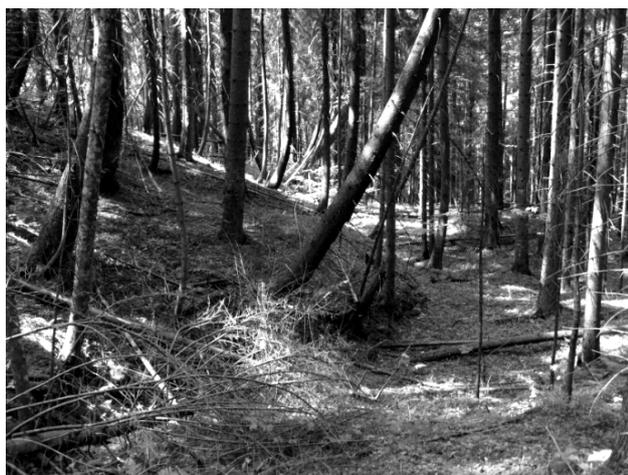
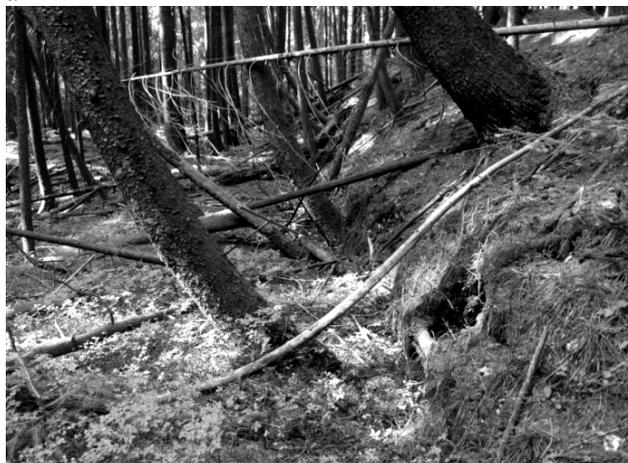
Figure 4. Aspects from new landslide: front lobe of landslide (a); secondary lobe from the upper part of the landslide (b). Note the tilted trees consequent with landslide direction.

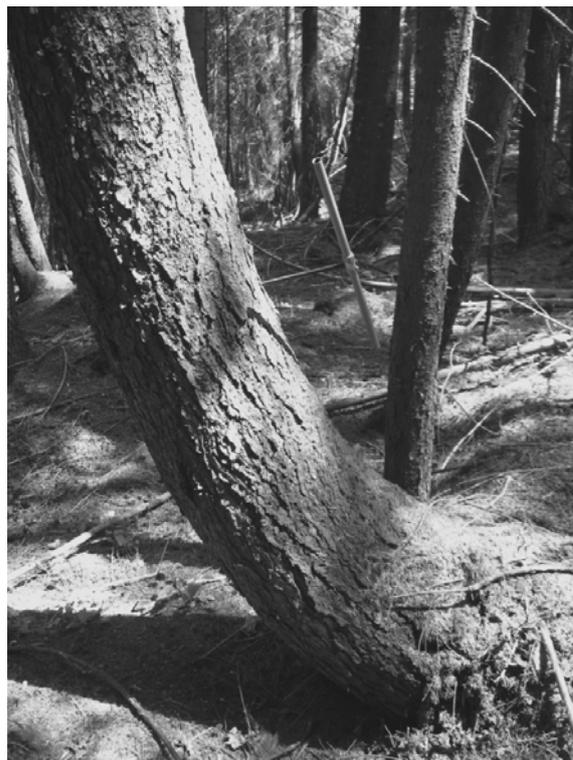
Figure 5. An example of sampled tilted tree.

An increment borer with a length of 40 cm and a diameter of 6 mm manufactured by Suunto Company was used to extract the cores. The increment borer was introduced into the trunk and with an extractor could provide a core with 5 mm in diameter (Fig. 5).

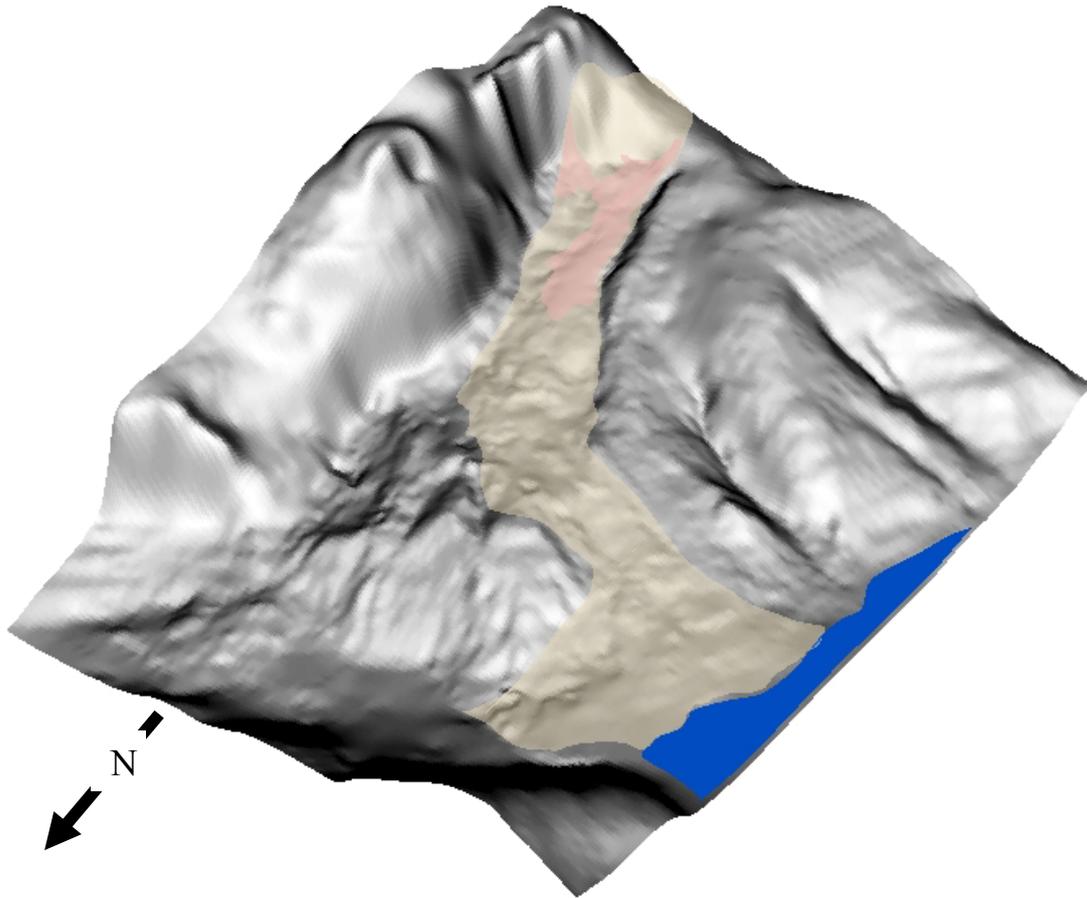
Figure 6. 3D image of the Red Lake landslide. In faded yellow – the old landslide and in faded red the new landslide.

The Red Lake landslide has SE – NW orientation and has a total length of about 1220 m and 120-190 m width (Fig. 6 and 7). The average slope degree is 15°. The old landslide has a surface of about 22 ha while the new one has only approximately 3 ha. In the bottom part, the landslide toe is spread in lateral on the former flood plain and reaches almost 475 m width. In plan, the landslide has a tongue shape which arched very slowly to NW.

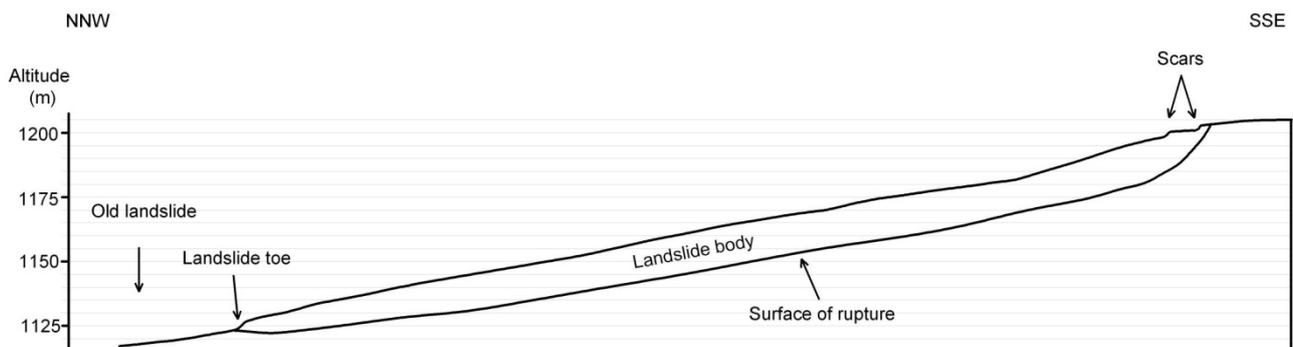
Figure 9. Longitudinal profile of the new Red Lake landslide

The samples for landslide dating were collected from a number of 20 tilted trees, 15 of them located on the front lobe or on the lateral lobe (Fig. 8 and 9). Other 3 samples were taken from the middle part of the landslide body and 2 samples near the scarp. From each tree were extracted two cores, one in upslope-downslope direction and one from reverse. The reference chronology was made using 10 samples collected from 5 trees located downslope the landslide lobe which have undisturbed and straight trunks, with no eccentric growth.

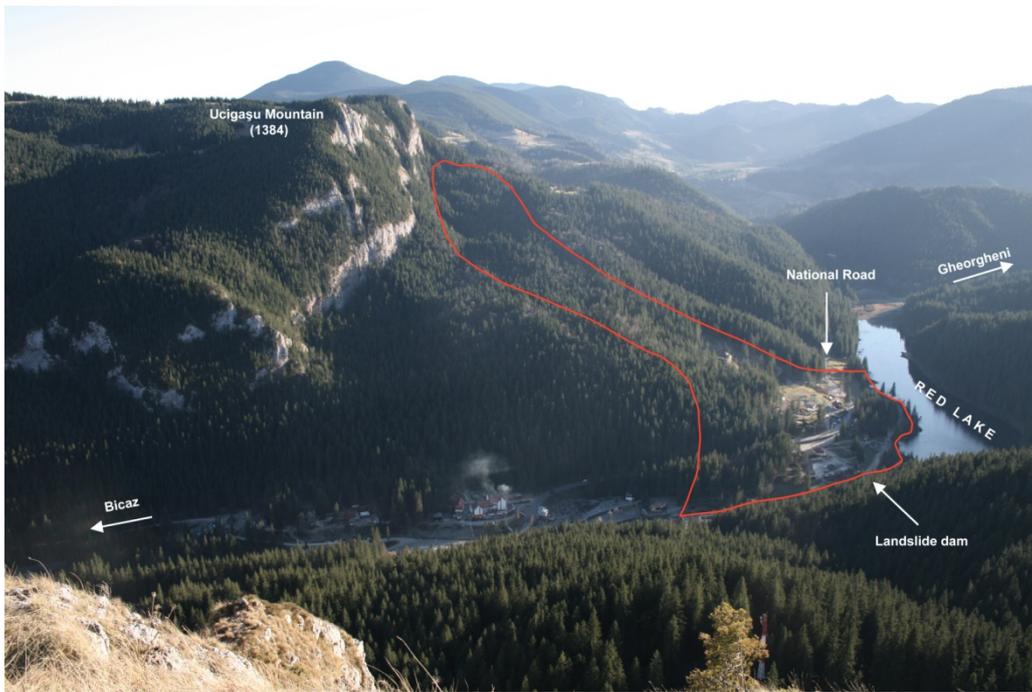
Figure 7. Picture taken from Suhardu Mare Peak, with the landslide marked by red line (photo Dan Grigore).

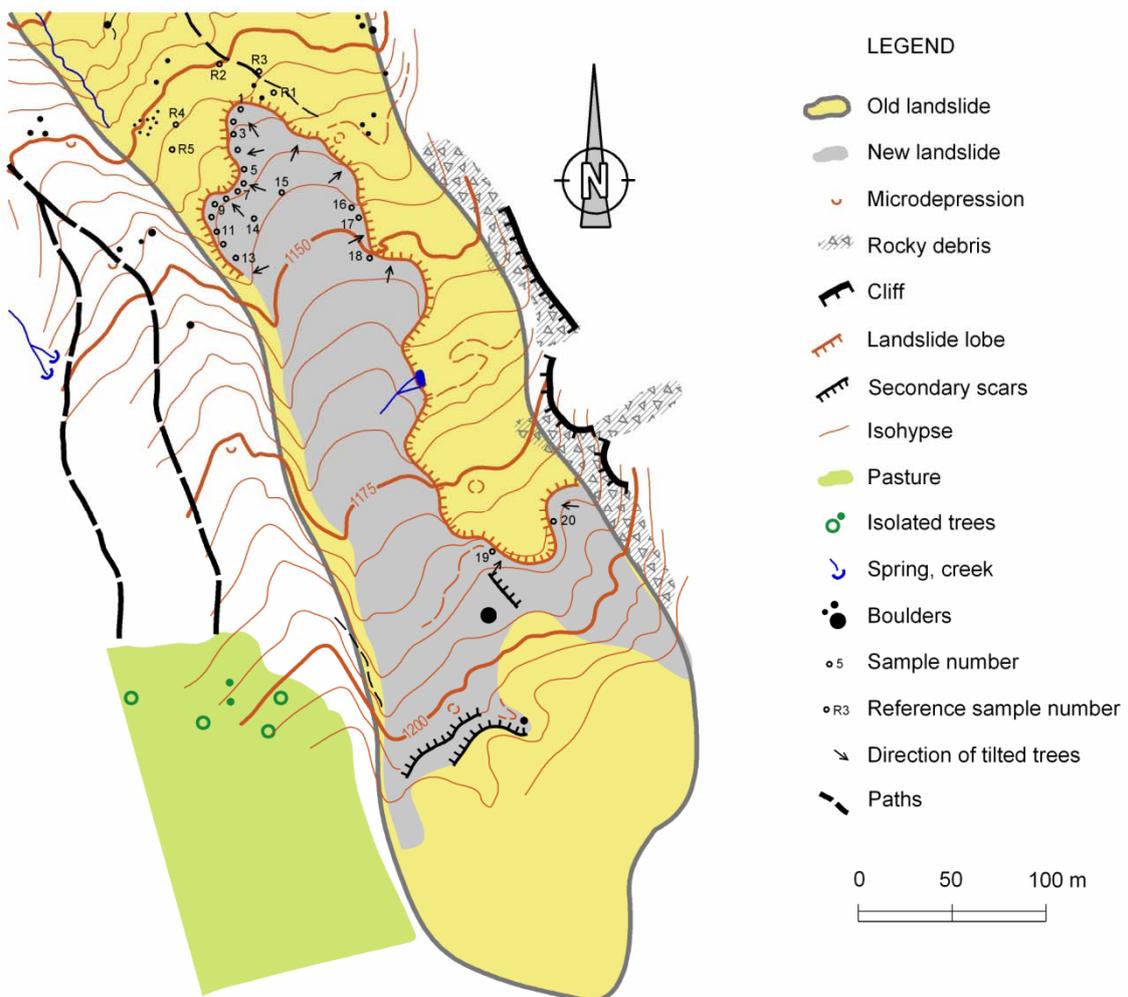
Figure 8. Sketch of the new landslide and location of sampled trees.

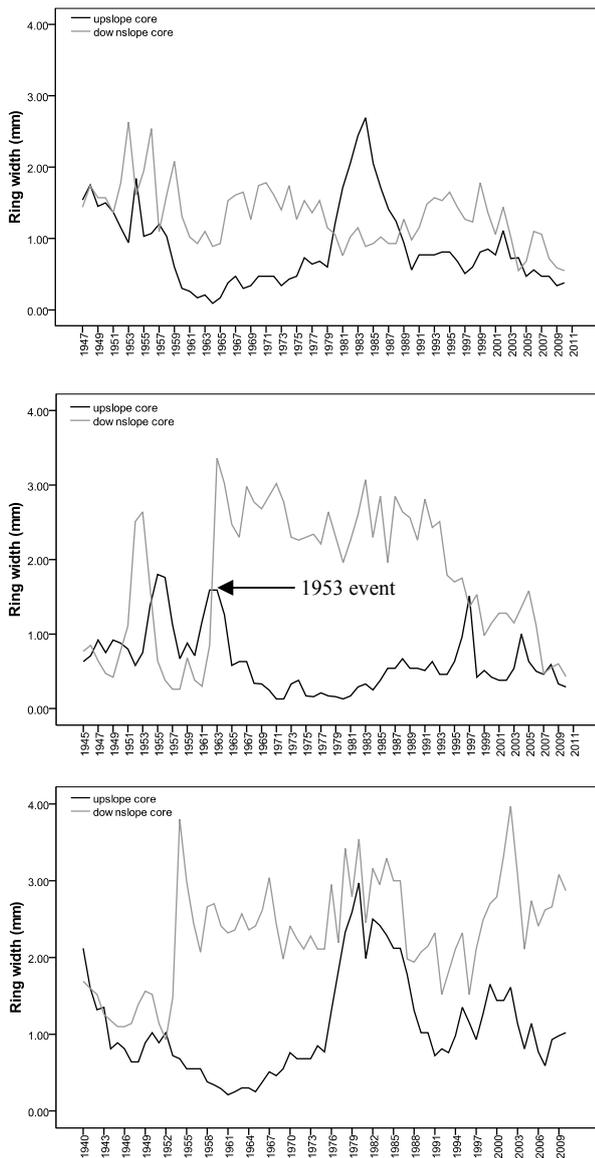
Figure 10. Abrupt growth in a few trees sampled from the new landslide; an event from which started in 1953 was found in trees no. 4, 13 and 17.

Despite all difficulties, we found in a few samples evidence of abrupt growth, which indicated a starting process during the years 1952-1953 (samples 1, 2, 3 and 17), 1957 (samples 4 and 15), 1959 (sample number 8 was already tilted which means that trees started to tilt in the first years of life, and also sample number 14), 1963 (sample number 13) (Fig. 10a, 10b and 10c). We have the certitude that the new landslide occurred in the 1950s or it was characterized by high rate of movement in this interval. The gap between the first appearance of the abrupt growth and the second one is perhaps due to the different velocity propagation of the landslide body.

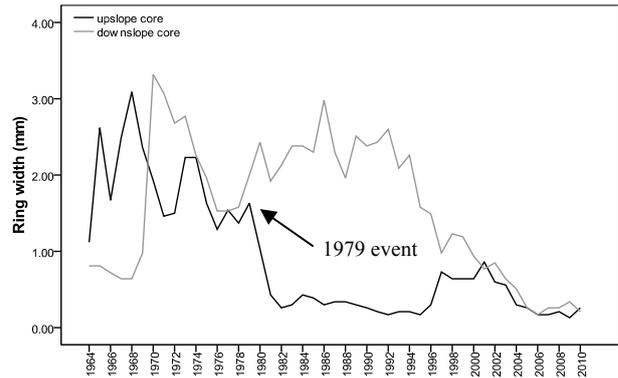
Figure 11. The second event from 1979 dating on tree number 6.

Another abrupt growth was identified for the year 1979 in three samples (samples 6 and 18) collected from the toe and lateral toe of the landslide (Fig. 11). The abrupt growth from this interval was induced probably by another important movement of the landslide. This assumption is partially based on the presence of the two secondary scars from the upper part of the landslide, which indicate a minimum of two important periods of movement. Also, the period between 1985 and 1989 presented a negative abrupt growth.

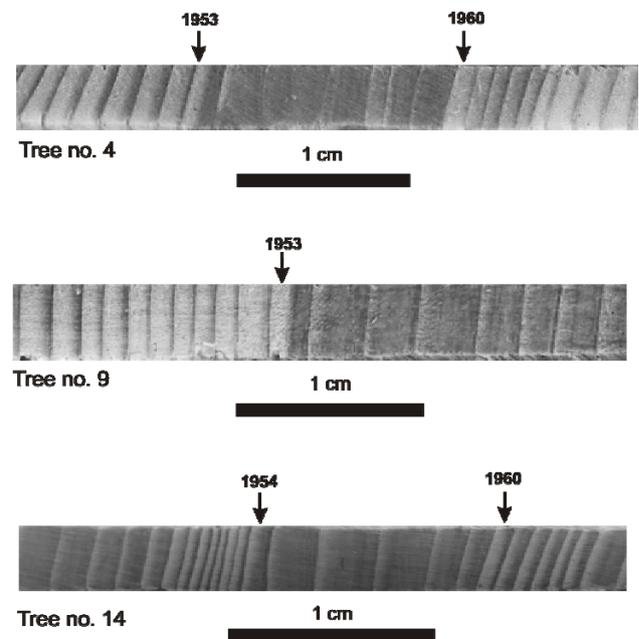
Figure 12. Compression wood located on the downslope part of the trees trunk (sample no. 4, 9 and 14).

The reaction wood (compression wood) was present in all samples. More than half of the samples started to develop compression wood since 1953-1954 (Fig. 12), which can be correlated with abrupt negative growth in tree 4, 13 and 17. The most relevant samples are presented in figure 12.
