## RAPID VISUAL SEISMIC SCREENING PROCEDURE FOR BUILDING STOCK IN BUCHAREST

**Abstract:** Bucharest is classified as the second metropolis in Europe, subjected to important losses in the case of a destructive earthquake. Evaluation of the seismic vulnerability of the city represents a tremendous task requiring swift structural vulnerability assessment tools. The seismic structural assessment of old, un-engineered, buildings using complex assessment methodologies is tributary to many uncertainties, having a high impact on the results. In this paper, a rapid visual screening (RVS) procedure to assess the seismic structural vulnerability is introduced. The proposed RVS procedure was applied for 335 buildings located in Bucharest, randomly selected from a database of buildings for which more complex seismic assessment methodologies were applied. Seven structural criteria having a high impact on the seismic vulnerability of the buildings were identified, based on the observations after the last destructive 1977 earthquake. These criteria were introduced in a scoring system to determine a general score that describe the seismic structural vulnerability. Based on the general score, each

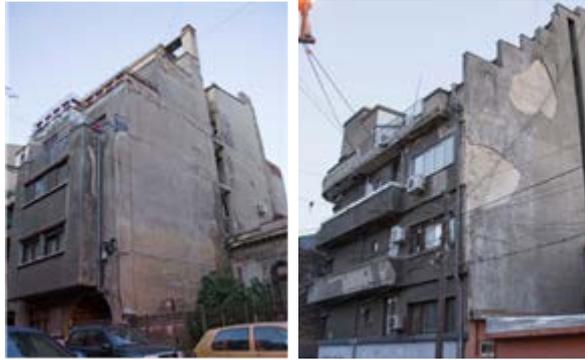
Figure 2. Vertically irregular concrete and masonry structures

- Vertical regularity: a building was considered regular in elevation if it had no systematic setbacks, from one story to another. Examples of buildings with vertical irregularity, as classified in this study, are presented in figure 2. A building having only one set-back at the top story was considered regular;

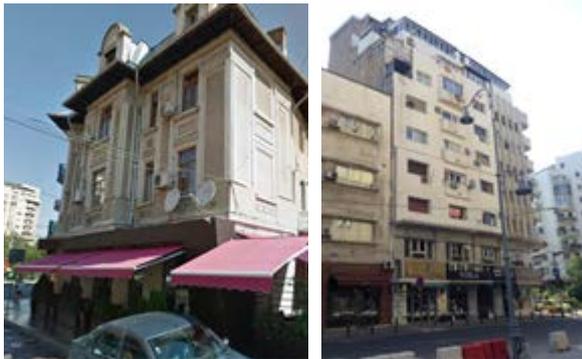
Figure 3. Different architectural layout of the ground floor in comparison with the upper stories

- Architectural layout of the ground floor in comparison with the layout of the upper floors. During the side-walk inspection it was noted if the destination (functionality) of ground-floor is different from the other stories, (Fig. 3);

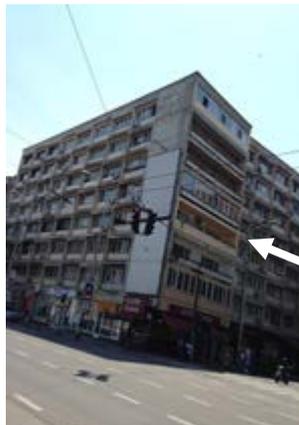
Figure 4. Pounding of adjacent buildings

- Position of the building with respect to the adjacent buildings: independent building (having no interaction with other buildings), interior building (located between other similar buildings, not separated by a seismic joint, with high probability of interaction) or corner buildings (located at the

street corner or at the end of a buildings row, near an adjacent building, not separated by a seismic joint) (Fig. 4);

materials, significant horizontal and vertical irregularities, presence of weak and flexible stories, lack of horizontal rigid diaphragms, pounding of adjacent buildings and discontinuous seismic load path. Usually, buildings being placed at the corner of the streets sustained more severe damage.

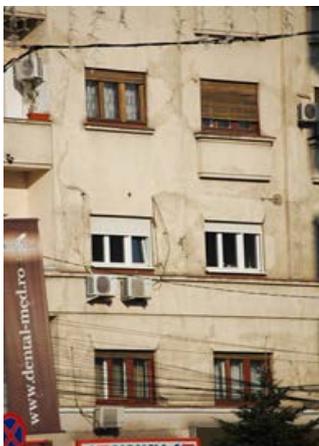
Figure 5. Earthquake damaged wall piers

- Existing visible damage in piers and spandrels. As most of the buildings were not retrofitted after the 1977 earthquake, it was still possible to notice structural damage from side-walk surveys (Fig. 5);

After the earthquake of March 4, 1977, a large number of buildings were destroyed or heavily damaged. The old masonry buildings, with or without concrete elements, sustained damage ranging from minor cracking of the masonry walls to total collapse. The following types of damage were largely identified in the post-earthquake inspection (Fattal et al., 1977): diagonal cracks in masonry piers and spandrels, shear cracks in columns and beams and spalling of concrete cover in concrete elements. The unsatisfactory behavior of old buildings was largely caused by the weak lateral strength and severely limited ductility, poor quality of the construction

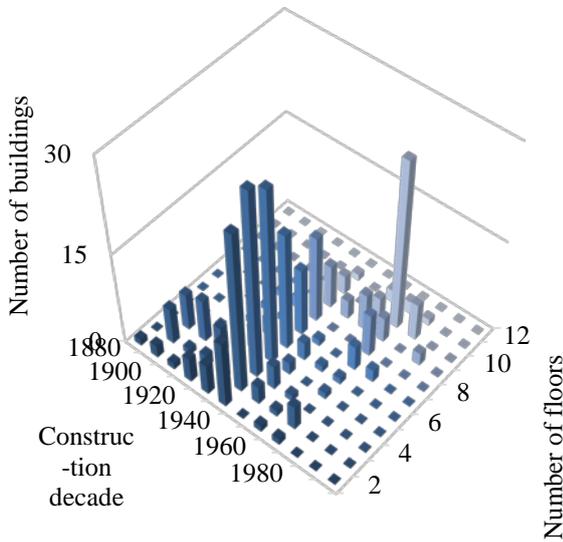
Figure 7. Distribution of inspected building with respect to the construction decade and number of floor.

The proposed RVS procedure was applied for 335 buildings located in Bucharest, randomly selected from a database of buildings for which more complex seismic assessment methodologies were applied. The majority of the inspected buildings belong to the decay 1920-1960, with a number of floors between 4 to 8 (around 75%). A general score describing the seismic risk associated with a building was calculated by assigning a score share for each criterion.

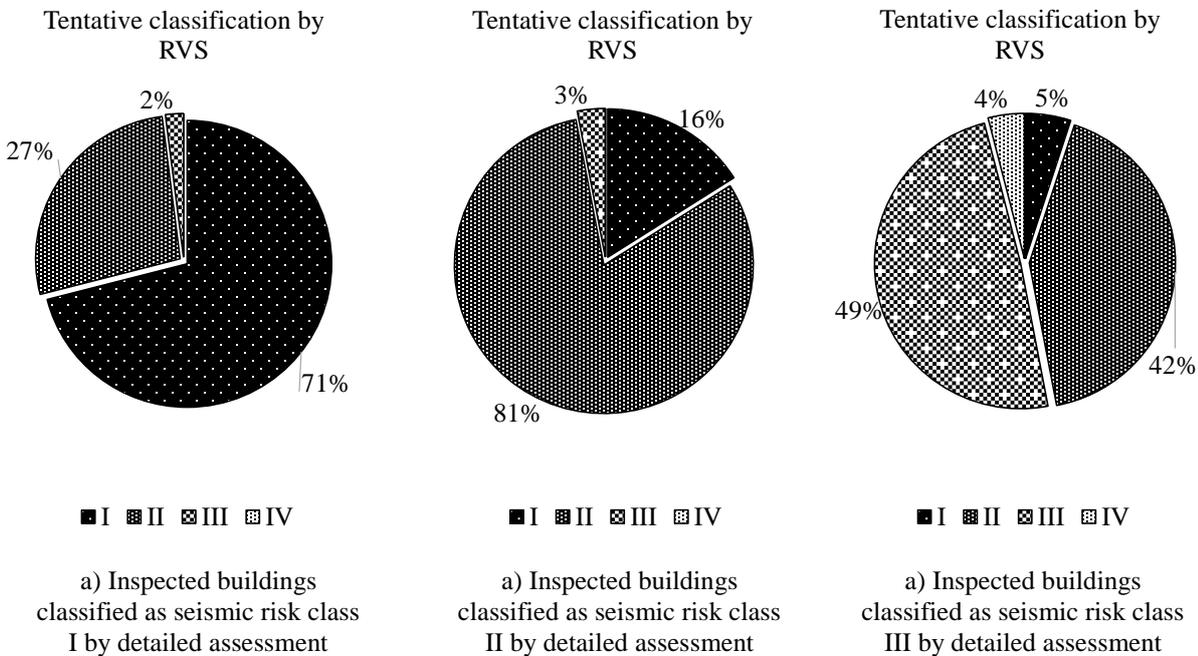
Figure 8 - Results comparison between the RVS and the detailed assessment

With the proposed RVS procedure, we conclude that 34% of the 335 inspected buildings belong to TRS class I, 55% to TRS class II and 10% to TRS class III. According to the detailed seismic assessment made by

experienced engineers, for the same inspected buildings 34% were ranked as seismic risk class I, 44% were ranked as class II and 16% were ranked as class III. The RVS showed a matching coefficient of 0.71 for buildings with high risk of collapse and 0.81 for buildings with moderate risk of collapse in comparison with more complex seismic assessment methodologies applied for the same buildings. The main advantage of the RVS procedure is obviously that it is implemented without performing any structural calculations. The
