## USEFULNESS OF SENTINEL-2 VISIBLE LIGHT SATELLITE PHOTOS FOR SURVEYS OF HYDRODYNAMIC PHENOMENA IN POLISH CARPATHIAN STORAGE RESERVOIRS

**Abstract:** The aim of the research presented in this paper was the recognition of potentials and drawbacks of visible light photos taken by the Sentinel-2 satellites as a source of data for hydrodynamic issues regarding dammed reservoirs located in the Polish Carpathian foothills. The authors analyzed the photos of five reservoirs: Goczałkowice, Tresna, Dobczyce, Czorsztyn and Solina. Depending on the object's geographic location, one can expect one or two photos taken during each 5-day period. No more than 1/5 of the taken photos of the given locations contain a non-obscured view of the water bodies. Visibility varies throughout the year along with the expected clear sky percentage; and the probability of obtaining a clear picture is lower than this value. In the Polish Carpathians, the best visibility occurs in August, while the worst in December. The chance of getting a clear view is lower during high discharge periods than in low discharge ones. In the clear photos the authors identified density currents of different nature: turbidity, rev

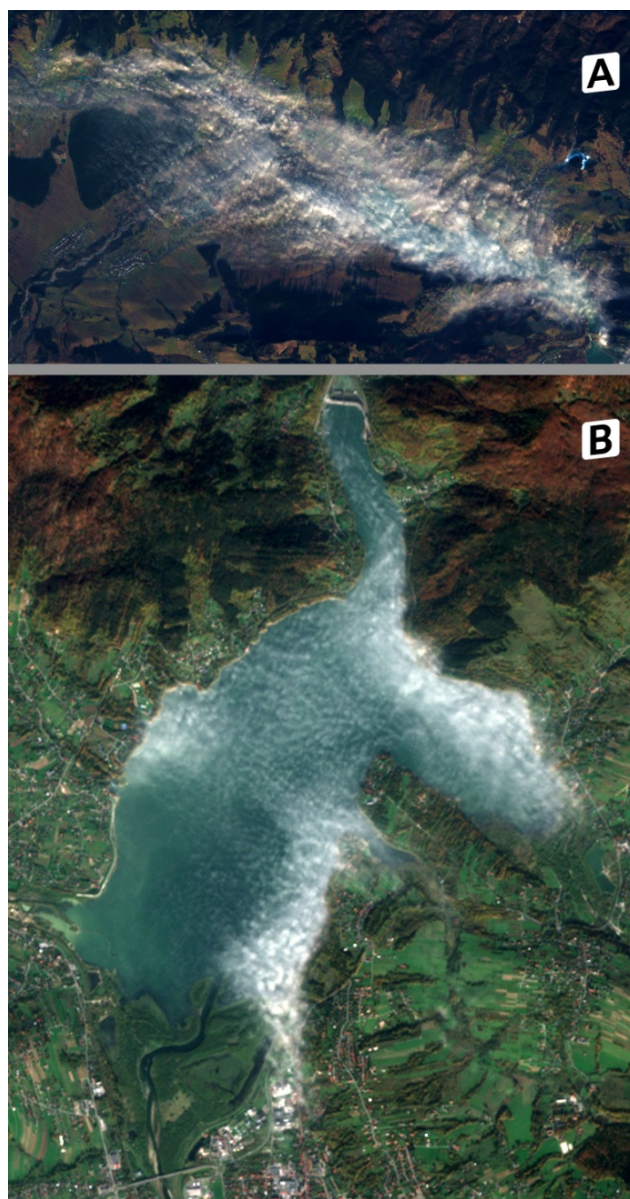
Figure 4. Czorsztyn (A) and Tresna (B) reservoirs view obscured by local mists.

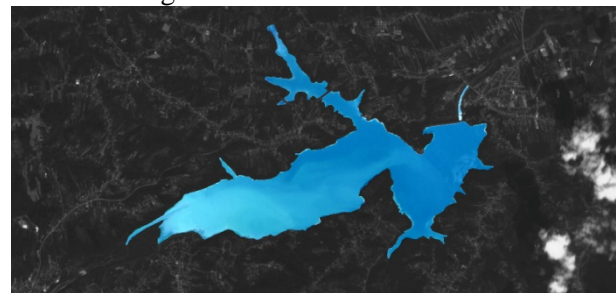
Figure 7. A turbidity current in the Dobczyce reservoir 2019.05.18.

turbidity currents (Fig. 7) and eutrophic water currents (Fig. 8). Moreover, in an inverted setup, where clear water enters a turbid or eutrophic area, the resulting current can also be distinguished (Fig. 9).

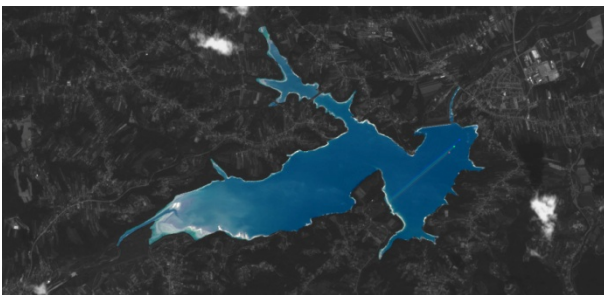
Figure 9. A clear water current entering the Dobczyce reservoir 2018.05.10 (the line visible in the eastern part of the reservoir is a trail of a jet plane).

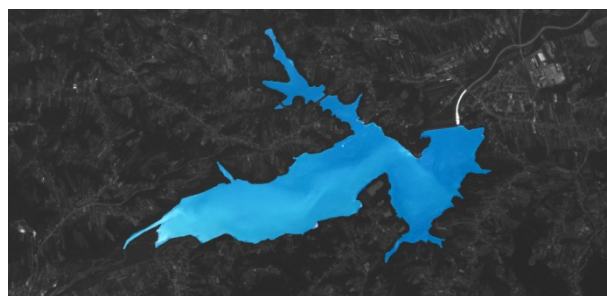
Figure 11. Turbidity current visible on the Dobczyce Lake during a high-water event 2018.07.22.

Therefore, the Sentinel-generated material regarding high discharges is still insufficient for detailed analyses. But even now some preliminary comparisons with model predictions can be performed. Figure 11 presents the Dobczyce reservoir taken 2018.07.22. The appropriate values of inflow and outflow discharges on that day were  $Q_{\text{in}} = 37\text{m}^3/\text{s}$ ,  $Q_{\text{out}} = 62\text{m}^3/\text{s}$ ; on the previous day they were  $Q_{\text{in}} = 83\text{m}^3/\text{s}$ ,  $Q_{\text{out}} = 78\text{m}^3/\text{s}$  respectively. The wind speed on

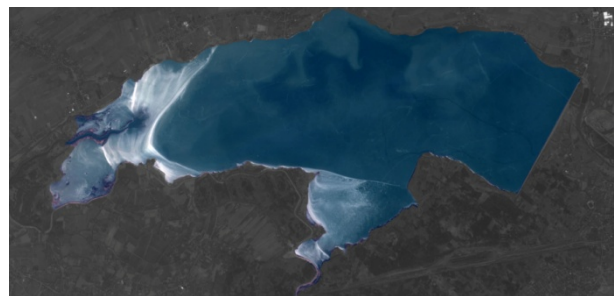
Figure 14. Sub-glacial flow in the Goczałkowice reservoir 2018.03.24.

Another example of sub-glacial currents visible is shown in Figure 14. Here the discharge is smaller than it was in the previous case:  $Q_{in} = 3.7\text{m}^3/\text{s}$ ,  $Q_{out} = 3.6\text{m}^3/\text{s}$ . There are meander-like forms visible to the north of the old river bed and embankments that are still present within the reservoir (Fig. 15). This suggests that the flow chooses that part of the reservoir, while water in the southern part remains stagnant. The flower-like radial shape in the northwestern part of the reservoir could possibly be connected with ground water leakages to the reservoir that are known to be present within this water body (Siudy et al., 2006; Trzewik, 2012). As a single image, the photo shown in Figure 14 is difficult to interpret, but it marks a promising direction of future research, as upcoming satellite images to compare it with will appear.

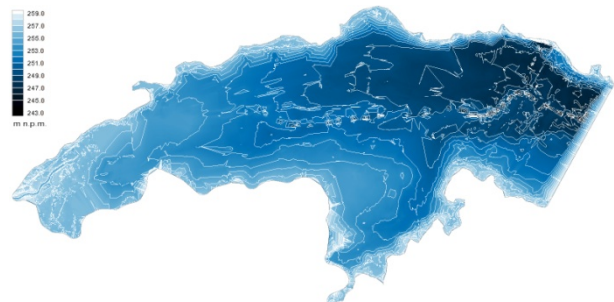
Figure 15. Bathymetric map of the Goczałkowice reservoir.
