## CORRELATION OF THE RELIEF CONDITIONS, HYDROGRAPHIC NETWORK FEATURES AND HUMAN INTERVENTIONS WITHIN THE BLAHNIȚA RIVER BASIN (SOUTHWESTERN ROMANIA)

Cristian RĂDUCĂ<sup>1</sup>, Sandu BOENGIU<sup>1</sup>, Oana MITITELU-IONUȘ<sup>1\*</sup> & Constantin ENACHE<sup>1</sup>

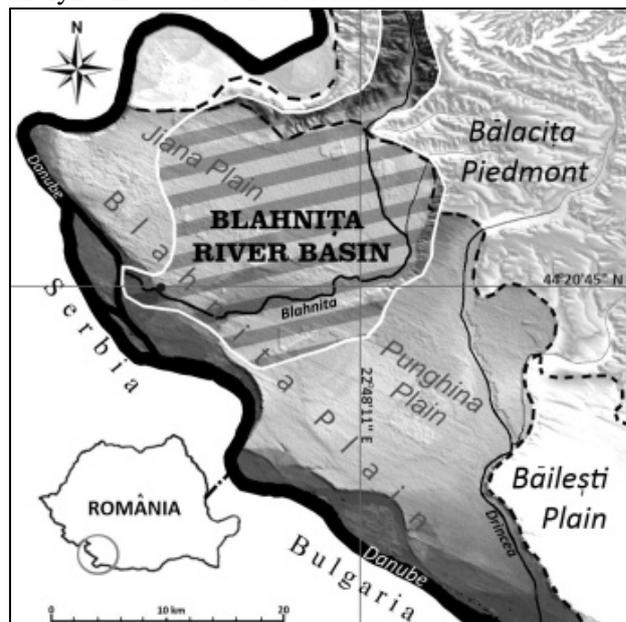
Figure 1. Study area: the Blahnița river basin in the Blahnița Plain

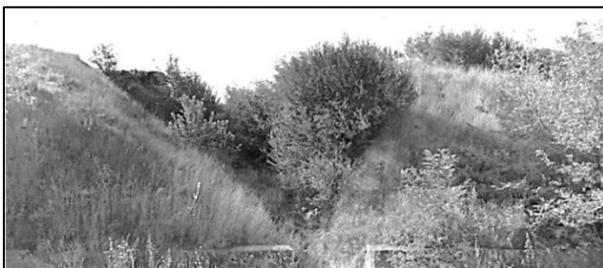
Figure 4. Ravine near N.Bălcescu (Răducă – April 2020)

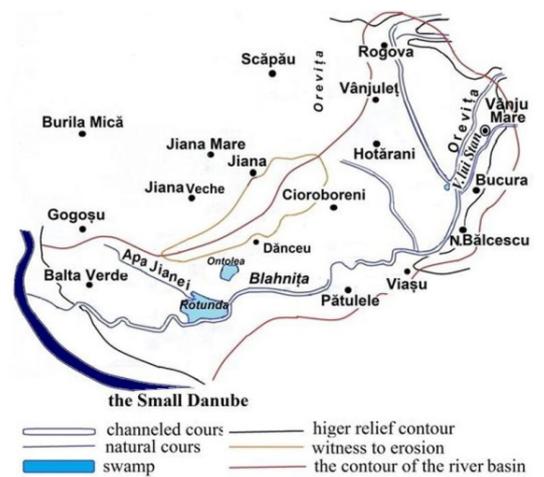
Figure 11. Blahnița hydrographic network in 2018

- The last stage of the analysis is the current one (2018-2020), which is based on current satellite images, corroborated with observations and measurements in the field (Fig. 11). The existing situation, at this stage, presents the Blahnița River channelized from Rogova to the discharge into the Danube, the canal being built next to Rotunda Lake, which is a private property and is arranged for sport fishing. It should also be mentioned that when

- In the current stage (2020) on the temporary Hotărani - Bălcescu water stream, an earthen canal was built to avoid digressions, and the Valea lui Stan water stream that descends from the piedmont to Vânju Mare was also channelized, and the Bucura water stream is completely clogged. Ontolea and Rotunda lakes are the only ones left with water surface. Rotunda Lake, a private property, is being adjusted for sport fishing, the Blahnița canal being built at the property boundary.

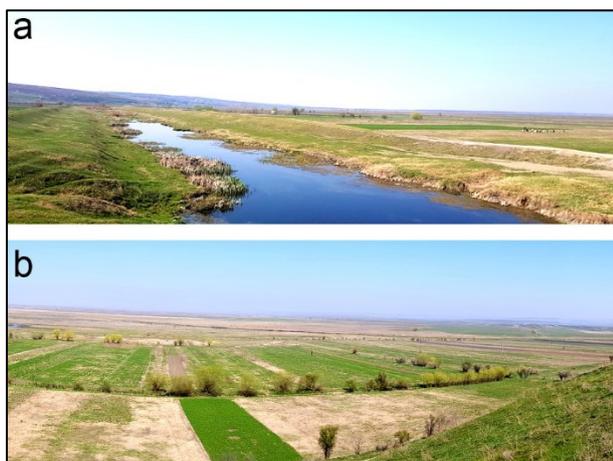
Figure 14. Human interventions within the Blahnița river basin: a. Dams along the Blahnița River (Bucura settlement); b. Swamps and ponds transformed in arable land (N. Bălcescu settlement)

Given this study results, we can claim that the surface of swamps and lakes has been drastically reduced in the last 40 years, from 1,510 ha to 346 ha. All these drained lands have been transformed into arable land (Fig. 14).

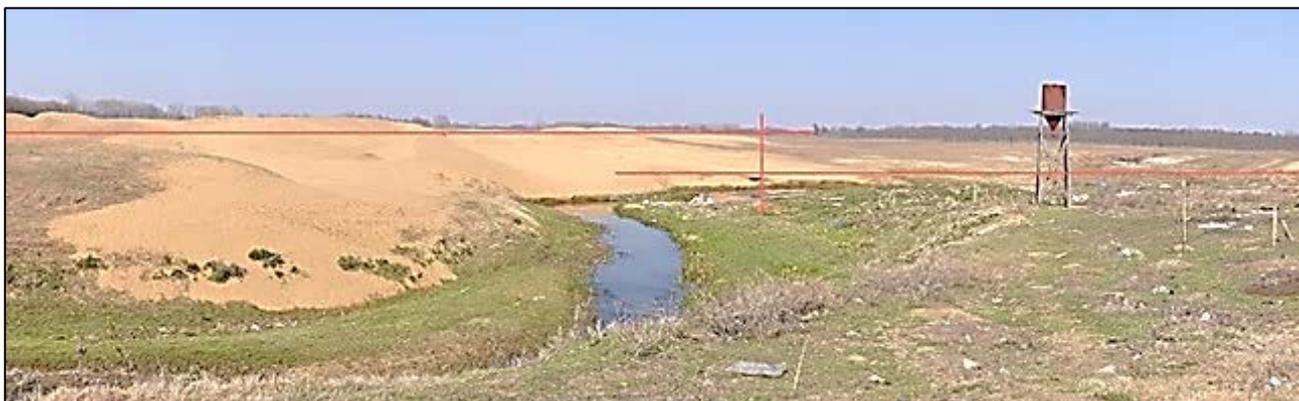
Figure 15. Sand dunes reactivated North of Pătulele (Răducă – June 2020)

well as inside the localities in this area. But another sand from the former swamps and lakes, now drained and dried, has joined the sand on deforested or uncultivated areas, and advanced further, reactivating some dunes, such as southwest of Jiana Veche, north of Patulele and north of Izvoarele. A clear evidence of dune activation, observed and measured during the 2020 field research (GPS South S82-T), is north of Pătulele (Fig 15). Its development is very clear on the western bank of Blahnița, which is rising almost 1m from the eastern one. Fortunately, in this case, the advance is stopped by the Blahnița river and Pătulele village.
