DEGRADATION AND GEOMYCOLOGICAL ASPECTS REGARDING THE NATURAL STONE FROM BUILT OUTDOOR

The present study is focused on heritage building stone gate from Ursuline Monastery, in Oradea town (Romania). The complex of heritage buildings, currently a historic monument, built 1771-1774, is located in the Oradea downtown. The house bought by the abbot István Szénczy to establish a girls' school was transformed into a convent; it began the construction in baroque style of the church "Saint Ana" (Chifor, 2018). Later on (1858) the convent was extended with a new wing and the portal to the entrance in the convent, located next to the church, were renovated in *Neo-Gothic* style (Chifor, 2018). At the beginning of the 20th century, the old rectangular windows from the ground floor, facing main pedestrian street, Calea Republicii,

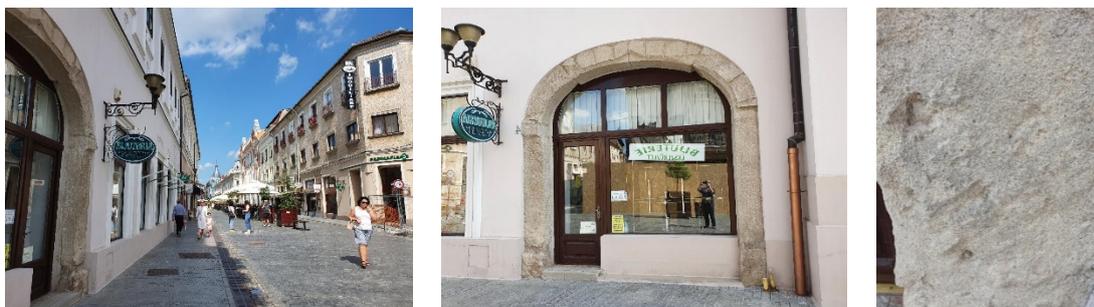
Figure 1. Location of the studied natural stone portal, Oradea downtown

a. Location of the heritage building, Calea Republicii pedestrian street, Oradea downtown

b. The analysed portal made by natural stone

c. Detailed view with degradation processes of natural stone of the portal

Oradea downtown, were replaced by decorative shop windows, paved with natural stone (Fig. 1 a, b, c) in the attempt to open a shop in the future (according the designing plans of the architect Ferenc Sztarill), function maintained till nowadays.

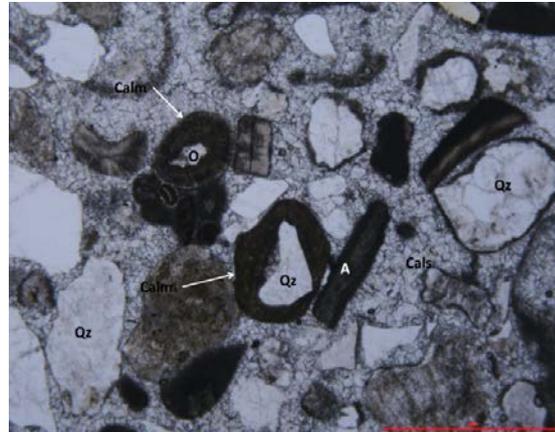
Figure 4. One polarizer microscopic image of sandstone with carbonate cement with quartz elements (Qz), composite ooids (O) with quartz core and micritic calcite crown (Calm) and red algae (A) embedded in sparitic cement (Cals)
